# RETROUT River Restoration Demonstration Case Reports

## RETROUT project report

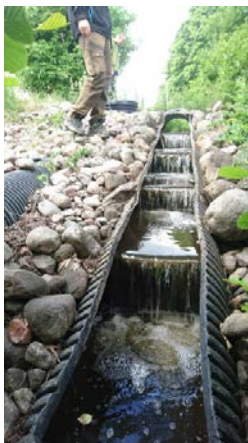
a. The old fish pass. Migration obstacle at low flow conditions.

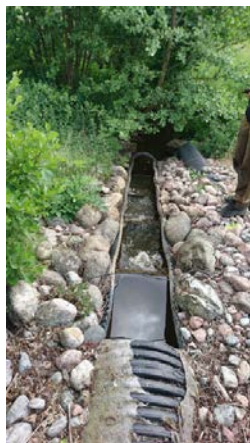
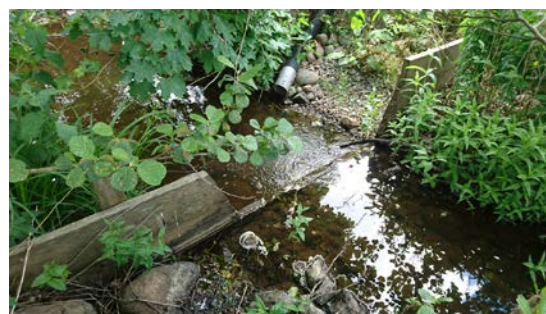
b. Wooden threshold downstream of the fish pass, Migration obstacle at low flow conditions.

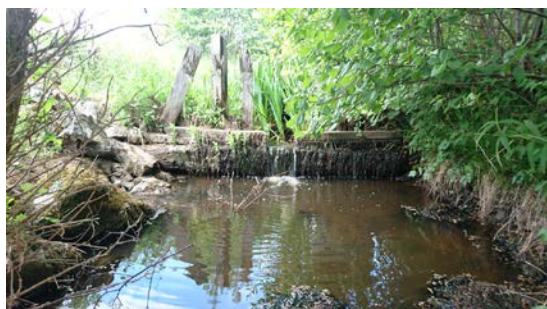
c. Wooden weir upstream the fish pass. Migration obstacle at low flow conditions

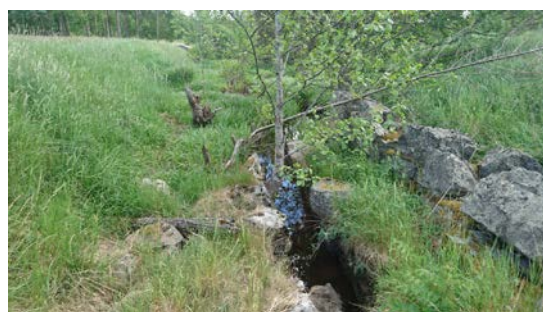
d. Remnants of an old water driven saw. Probably not a migration obstacle
