# RETROUT River Restoration Demonstration Case Reports

## RETROUT project report

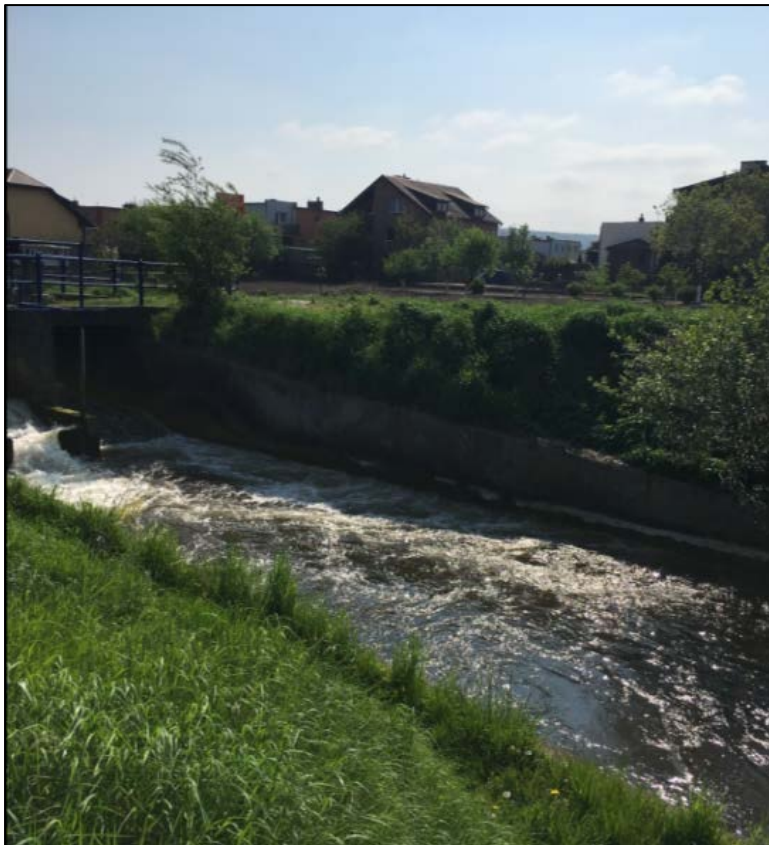
Figure 40. View of the Ciechocino weir and the left bank of the Reda River. Photo credit: National Water Holding "Polish Waters".

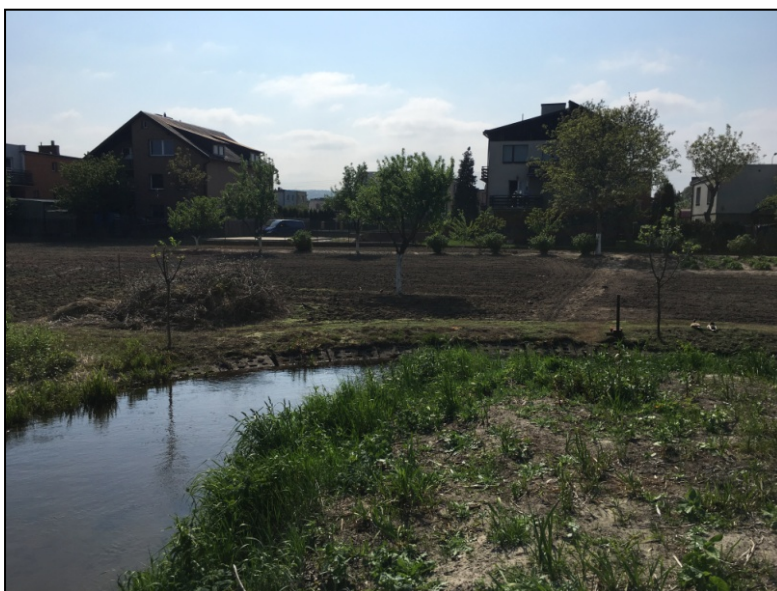
Figure 41. View of the Mrzezino Canal, the site of the fish pass construction. Photo credit: National Water Holding "Polish Waters".

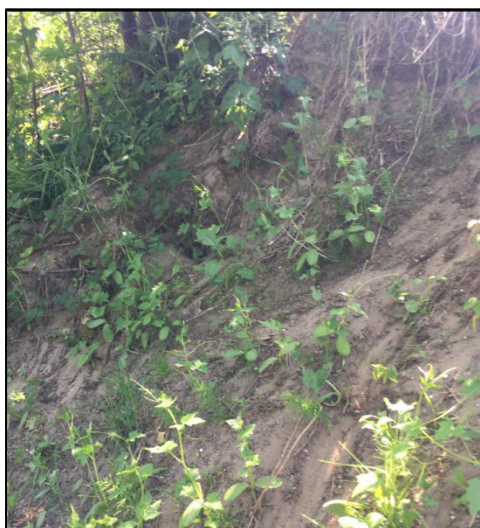
No protected plant species were found in the fish pass area. Noteworthy is the presence of an invasive species, *Echinocystis lobata* (Figure 42). An inventory of dendroflora was carried out in the area of the

Figure 42. View of the escarpment with *Echinocystis lobata*, an invasive species. Credits: National Water Holding "Polish Waters".

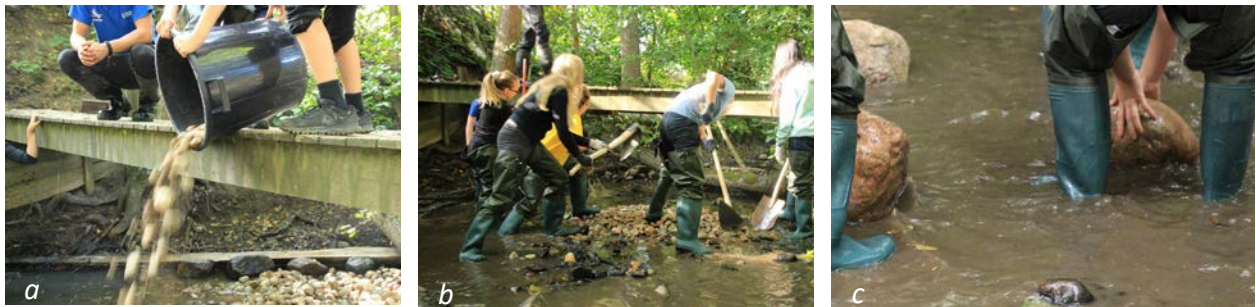
*Figure 50a-c. Pictures from when students help to create a spawning ground and place larger stones in the Bränningeån river. The project with the students was carried out before the restoration with machines.*

Before the restoration in Bränningeån, teachers at a nearby middle school were contacted. Together with the teachers, a class was carried out on river ecology, the restoration of watercourses and sea trout biology for 4 school classes (Figure 50). The teachers prepared the students at the school and then the students themselves got to create a spawning area and roll larger stones into the river. In total, four days of restoration was carried out with the school classes. Afterwards, the teachers had follow-up activities about the activity. By linking larger nature conservation projects with activities aimed at schools and the general public, there is a good opportunity to create a better understanding of nature conservation measures. The results of the collaboration project with the school were very successful and there are already thoughts of doing similar activities in the future.

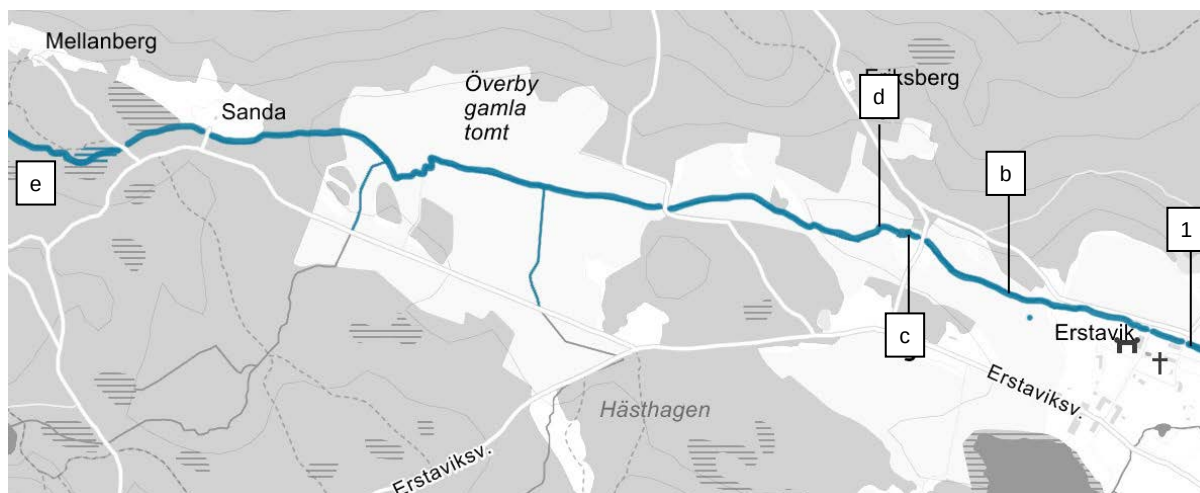
Figure 56a-e. The letters refer to comments and photos below. Photo: Oliver Karlöf.

There are three man-made migration obstacles in the creek. The lowermost is a poorly functioning fish pass situated close to Ersta Manor, 200 m from the river mouth. In theory it is passable for seatrout, but in reality, only a few trout are found upstream, despite better spawning grounds.

Based on the electrofishing and river habitat survey data it is concluded that that the poor status of sea trout (and river lamprey) is at least in part caused by the migration obstacles and poor river morphology. Possible restoration activities include removal or improvement of the fish pass, tree planting in the riparian zone, habitat improving measures e.g., re-introducing gravel and large stones to create spawning grounds and holding spots. The planned restoration activities are described in Figure 56.

a. The old fish pass. Migration obstacle at low flow conditions.

b. Wooden threshold downstream of the fish pass, Migration obstacle at low flow conditions.

c. Wooden weir upstream the fish pass. Migration obstacle at low flow conditions

d. Remnants of an old water driven saw. Probably not a migration obstacle

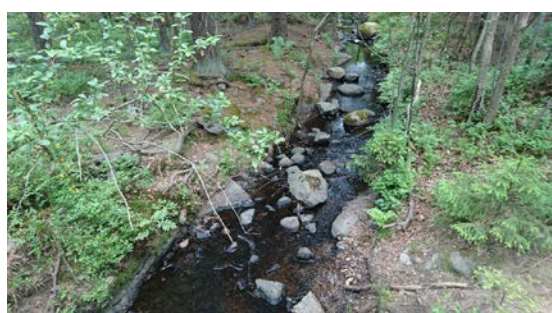
e. Potential spawning grounds close to the source lake (Sandasjön)
